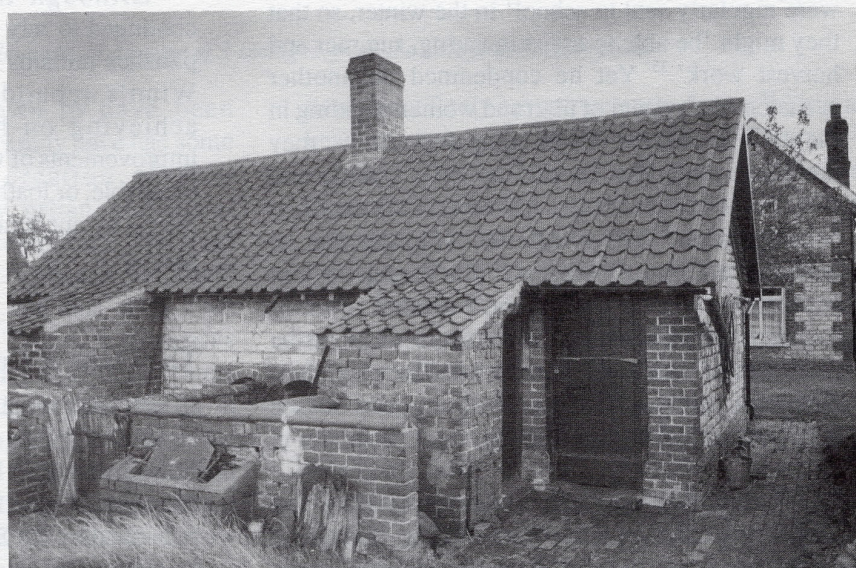
Fig. 17 Nos. 9 and 11
Carr Lane
